# Manhole Inspection Summary

Manhole # S11Y\_\_016MH

Insp Date: **4/7/08 10:16 AM**

**Location** Address: **1201 Bloomfield Ave**

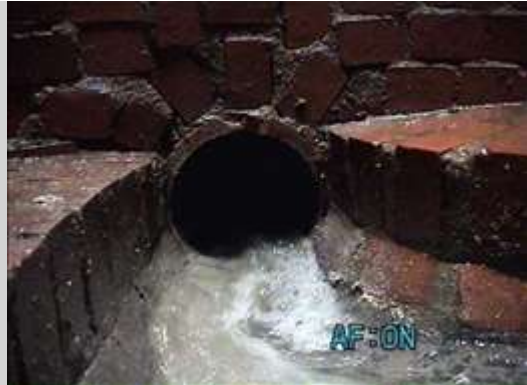
12 O'Clock Outflow

Pipe Height: **7.2** (in.) Rod and Bar (Angled)  
Pipe Material: **Clay** ☐ Pipe Lined  
Invert Depth: **12.66** (ft.) Flow Characteristics: **Fast**  
Deposits: ☒ None ☐ Mud ☐ Sludge ☐ Debris ☐ Grease  
Silt Depth: **0** (in.) Deposits Extent:  
Infiltration: **None** Pipe Seal Cond: **Sound**

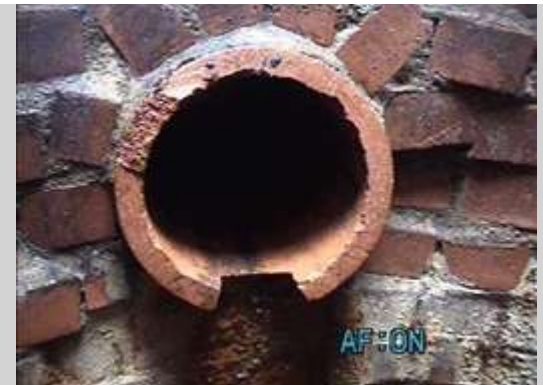
3 O'Clock Inflow

Pipe Height: **7.2** (in.) Rod and Bar (Angled)  
Pipe Material: **Clay** ☐ Pipe Lined  
Invert Depth: **6.66** (ft.) Flow Characteristics: **Fast**  
Deposits: ☒ None ☐ Mud ☐ Sludge ☐ Debris ☐ Grease  
Silt Depth: **0** (in.) Deposits Extent:  
Infiltration: **None** Pipe Seal Cond: **Sound**

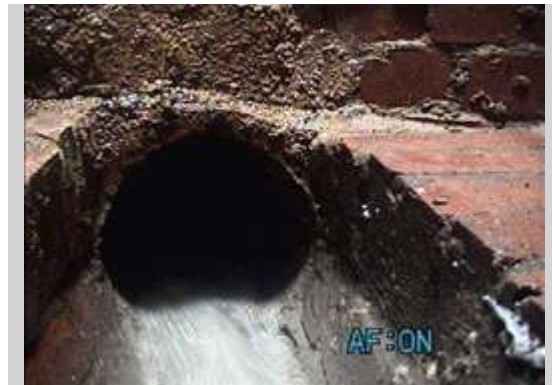
Drop In @ 3 O'Clock

Drop: **Inside** Rod and Bar  
Angled: **Yes** Reading: **11.06** (ft.)  
Inv Depth: **12.06** (ft.)  
Drop Condition: **Open**

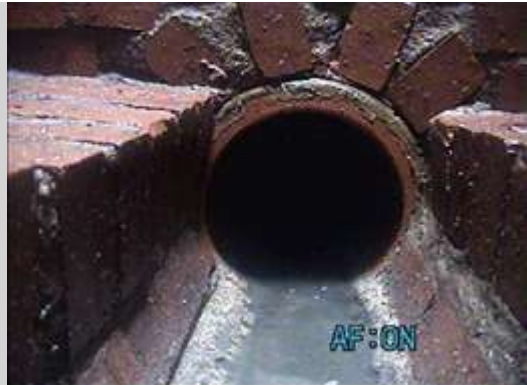
6 O'Clock Inflow

Pipe Height: **8.4** (in.) Rod and Bar (Angled)

Infiltration: **None** Pipe Seal Cond: **Sound**
